Water Compliance Inspection Report

Name and Location of Facility Inspected (For industrial users discharging to POTW, also include POTW name and NPDES permit number) Homefire Prest Logs Ltd. 6925 Salashan Parkway Ferndale, Washington 98248	Entry Time/Date 10:45 AM/ 12/15/17	Permit Effective Date 01/02/15
	Exit Time/Date 1:25 PM/ 12/15/17	Permit Expiration Date 12/31/19
Name(s) of On-Site Representative(s)/Title(s)/Phone and Fax Number(s) Virginia Hermanson/Sales and Marketing/(360) 366-2200	Other Facility Data (e.g., SIC NAICS, and other descriptive information) SIC = 2499	
Name, Address of Responsible Official/Title/Phone and Fax Number Clayton Hermanson/Head of Operations/(360) 366-2200	Latitude: 48.894553 Longitude: -122.610779	
Contacted <input checked="" type="checkbox"/> Yes <input type="checkbox"/> No

Inspection Date	December 15, 2017
Time Arrived	10:45 AM
Time Departed	1:30 PM
Weather Condition	Rainy
Facility Representatives Present	Virginia Hermanson
EPA Inspectors Present	Joe Roberto (Lead Inspector) Sandra Brozusky
Observed Discharge	I saw water flowing in the discharge pipeline along the east side of the facility. However, it is unknown whether this water was discharg

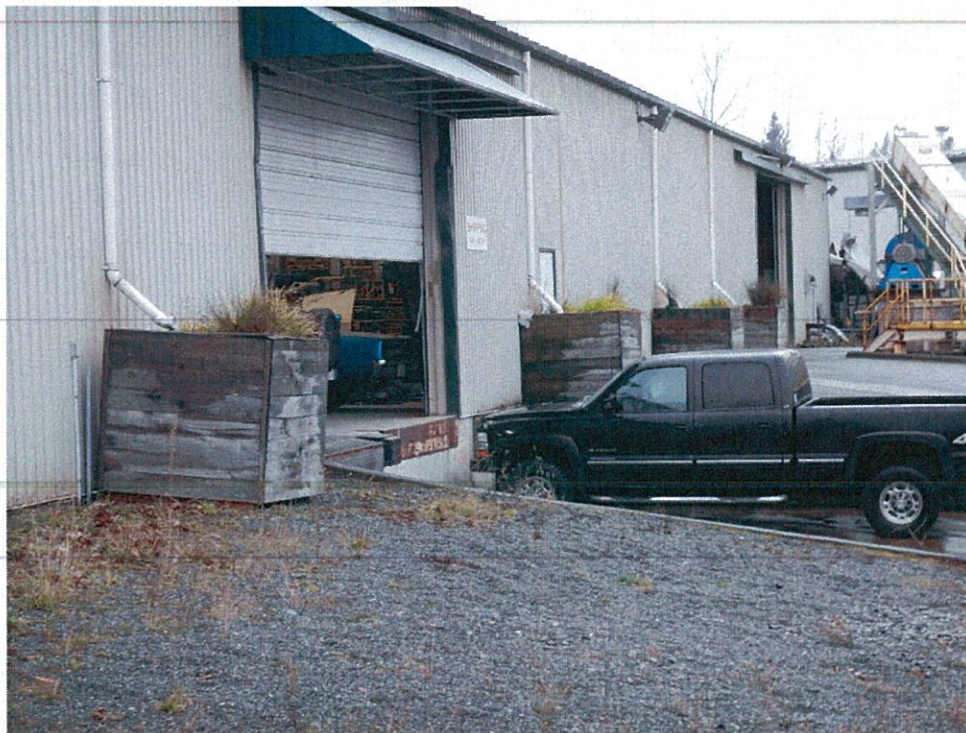
Photo #2: View of the "Grattix" treatment filters installed by the facility for roof runoff. According to Ms. Hermanson, the facility installed a total of 8 treatment filters to treat roof runoff. Four of the eight can be seen in this photograph. #DSCN0584.JPG.

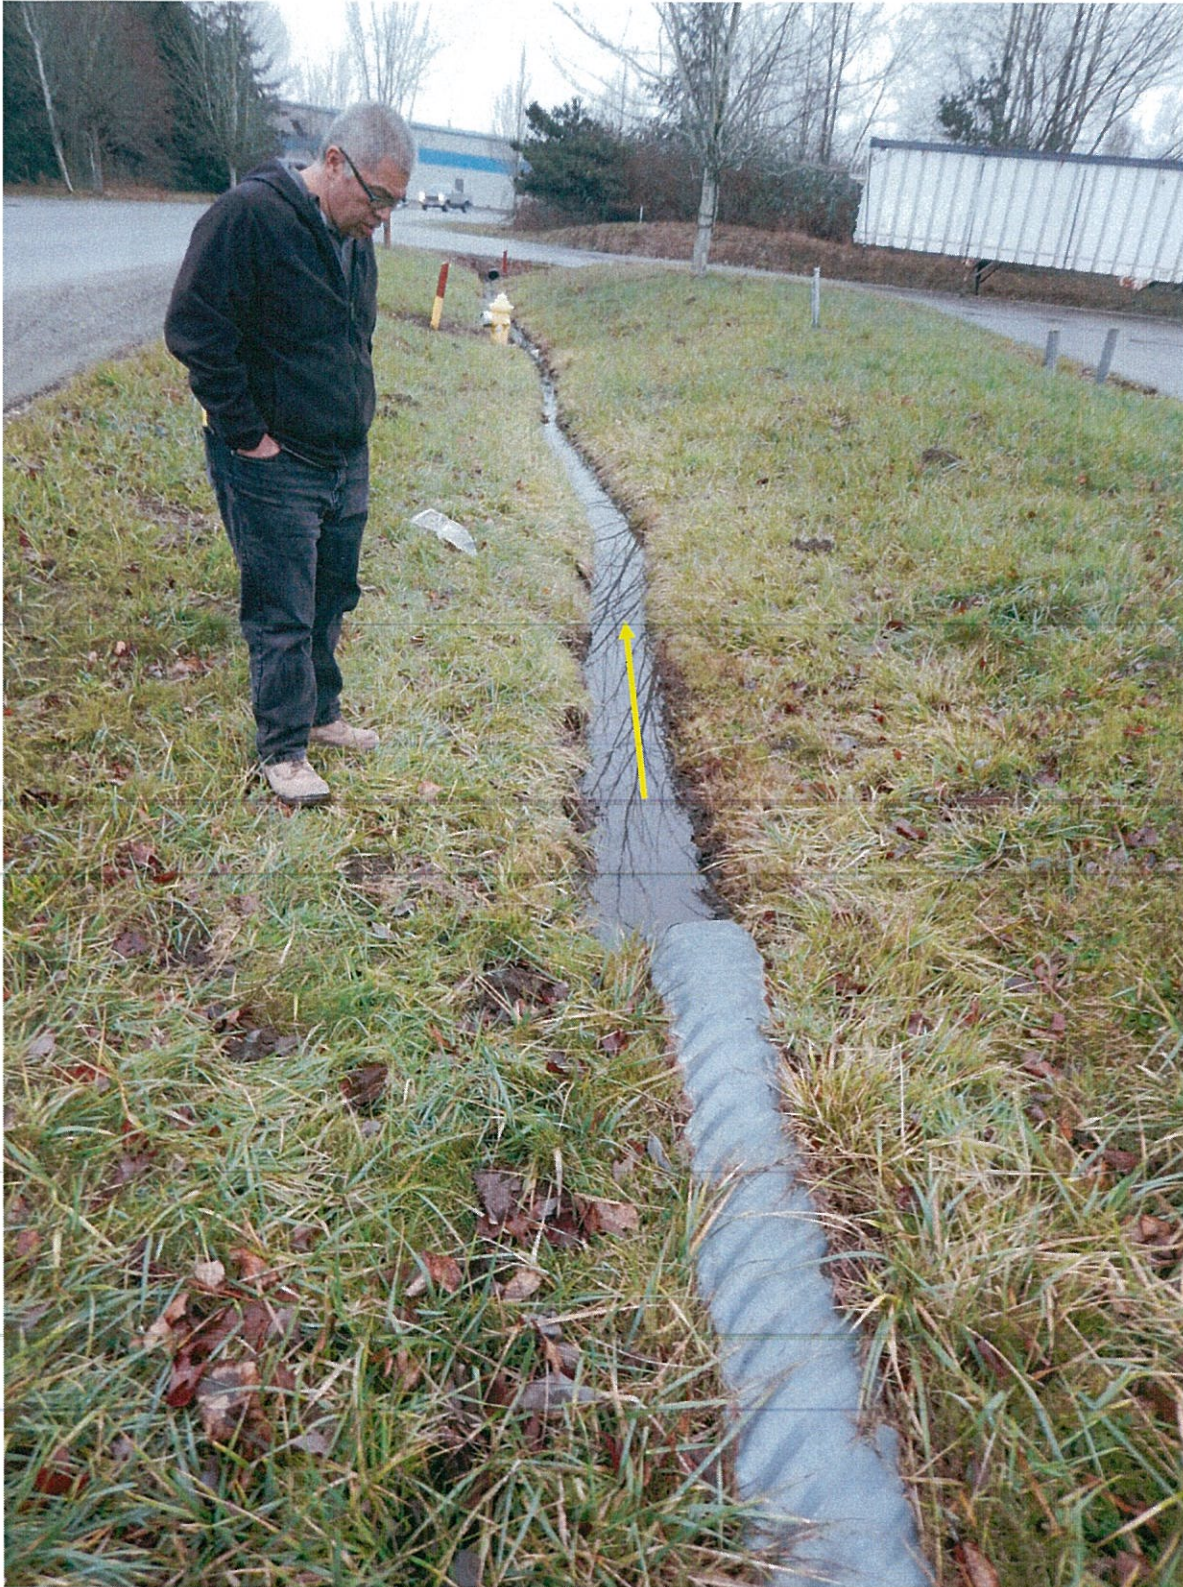
Photo #3: Southeasterly view of the facility's stormwater sampling location. Water seen here will be routed to California Creek. #DSCN0582.JPG.

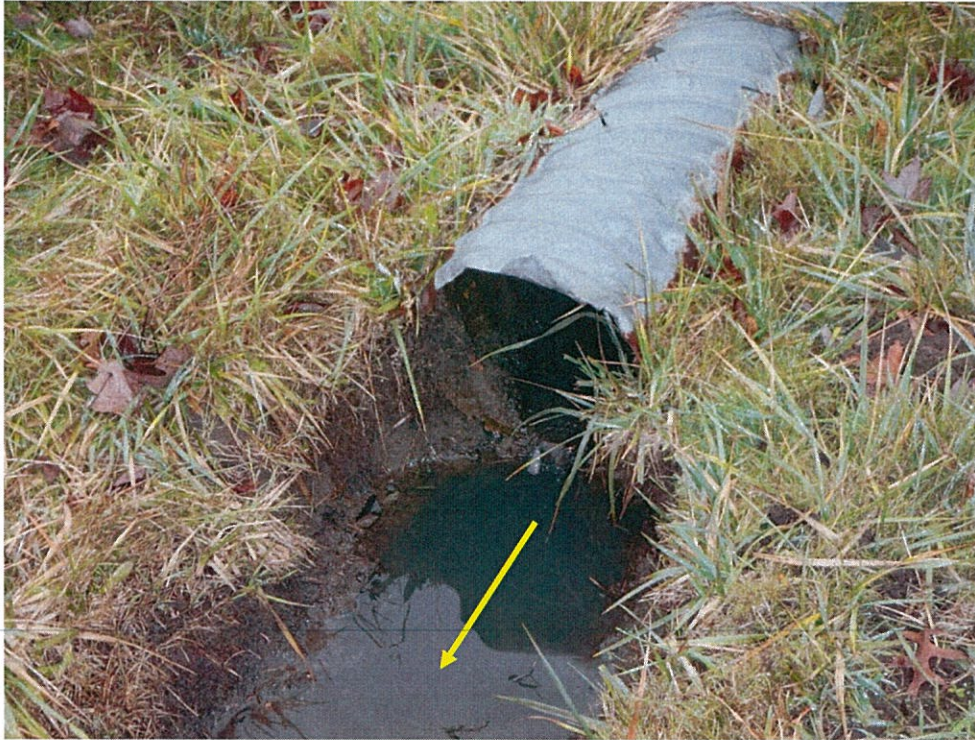
Photo #4: Up-close view of the facility's stormwater sampling location. #DSCN0583.JPG.

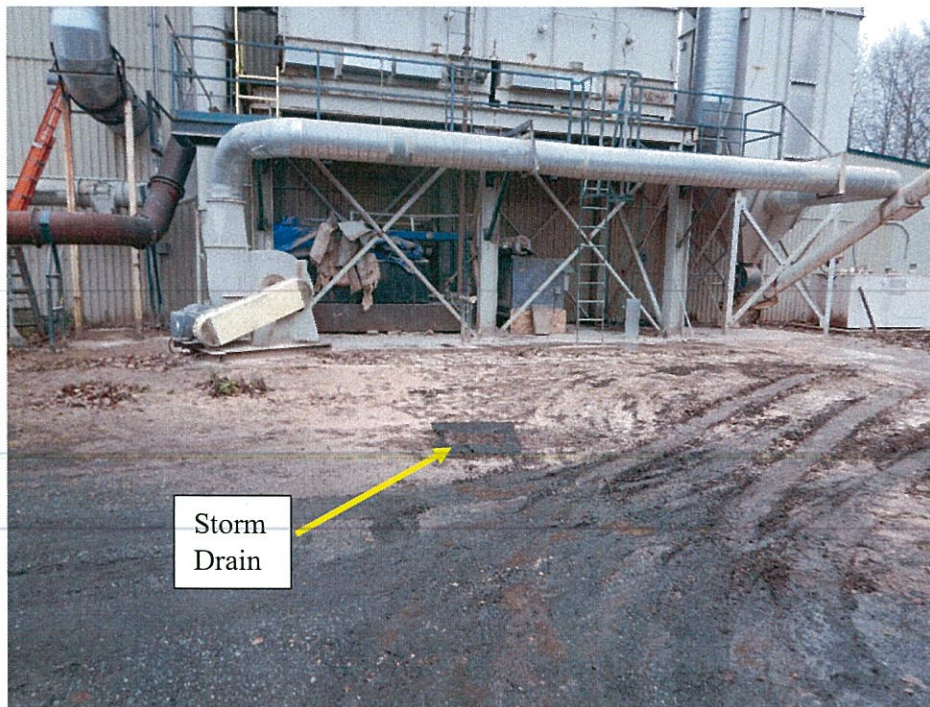
Photo #5: View of a storm drain located on the west side of the facility. According to the facility's SWPPP this drain leads to a pond located west of the facility as part of a commercial development complex. #DSCN0585.JPG.
